WESTRAIL Track Structures Section Draft Report TS 403.1/30

RAILWAYS OF AUSTRALIA Vehicle/Track Studies: Study No 2.

VOLUME TWO: DRAFT TECHNICAL REPORT

Section 2: Test Section Performance
December, 1993

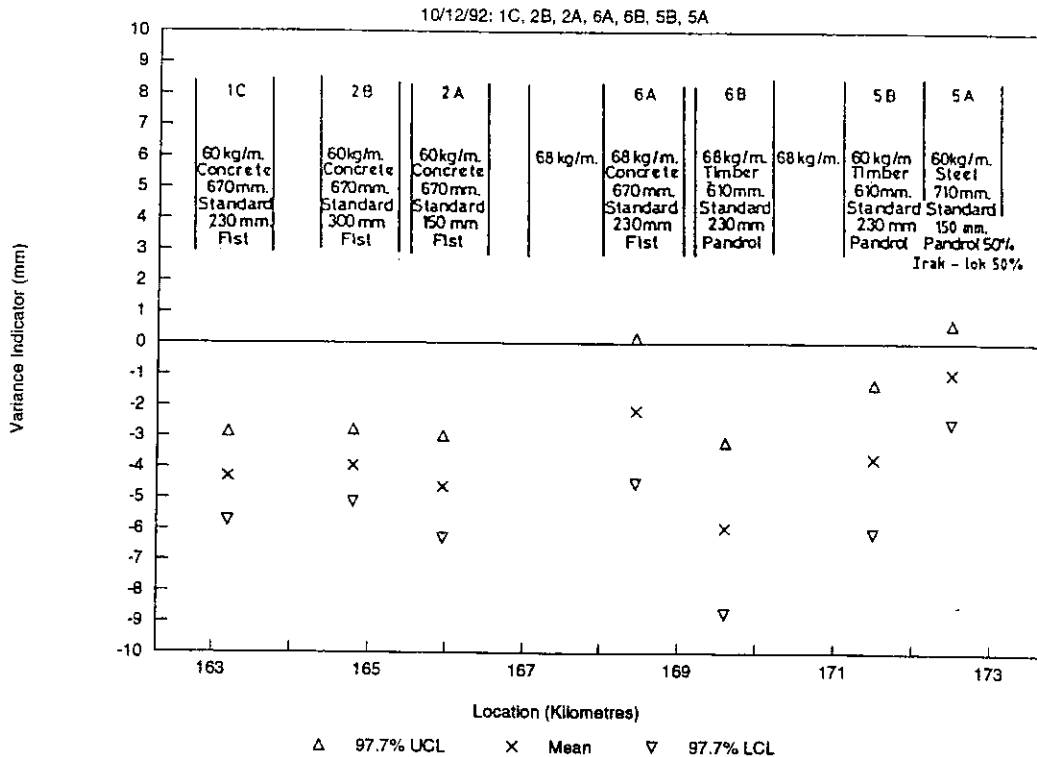
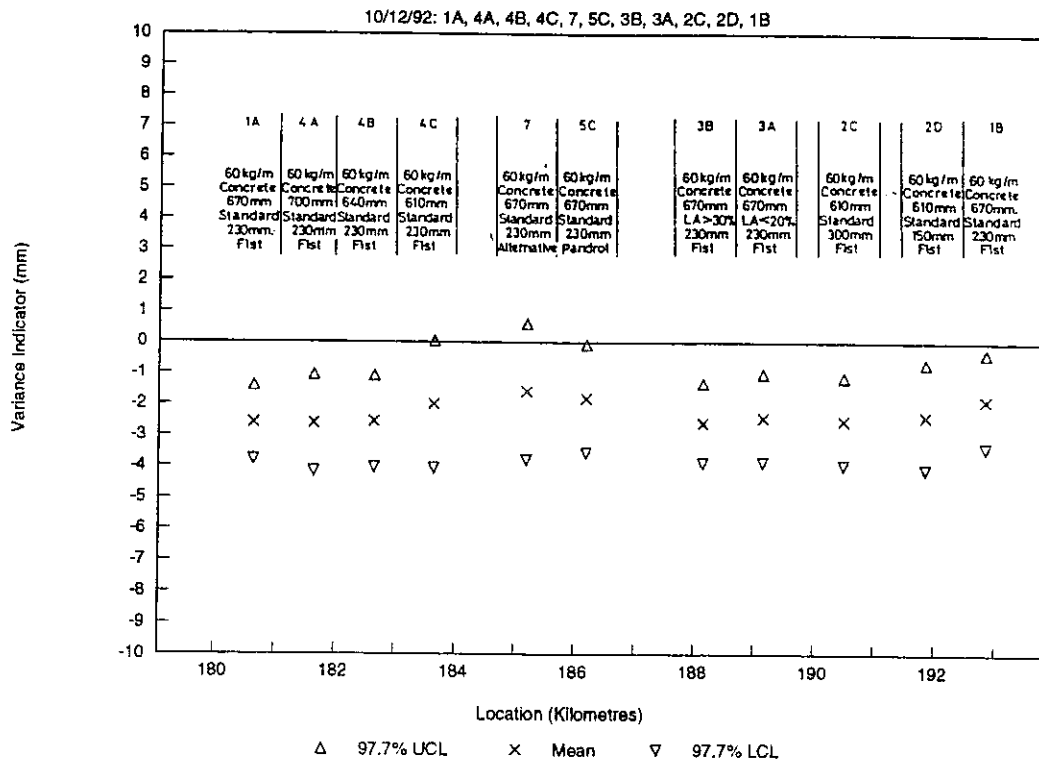
Figures 2.1.1(i)&(ii)
Gauge variance: 500 metre mid Test Section averages: DECEMBER 1992.

With the gauge quality indicator for example, see Figures 2.1.1(i)&(ii) (which are duplicated in Appendix Figures A8.1(i)&(ii)) the higher the magnitude, the greater the departure from nominal gauge (negative magnitudes are tight) on the date the recording run was made.

It has been separately observed that concrete sleepers exhibit weather shrinkage. The test track was also constructed with approximately 3mm tight gauge, see WESTRAIL report TS 403.1/1, Duncan 1984, This is reflected in Figures 2.1.1(i)&(ii). The tightening of gauge in the timber Sections 6B and 5B is apparent and not typical of timber sleepers track.

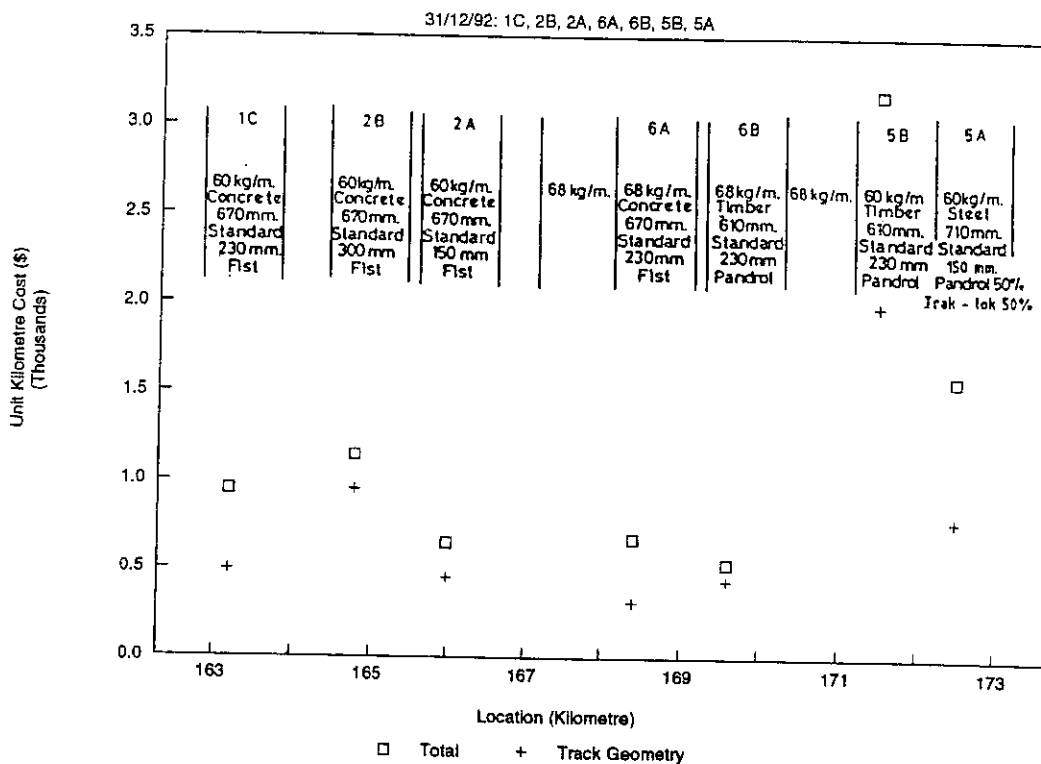
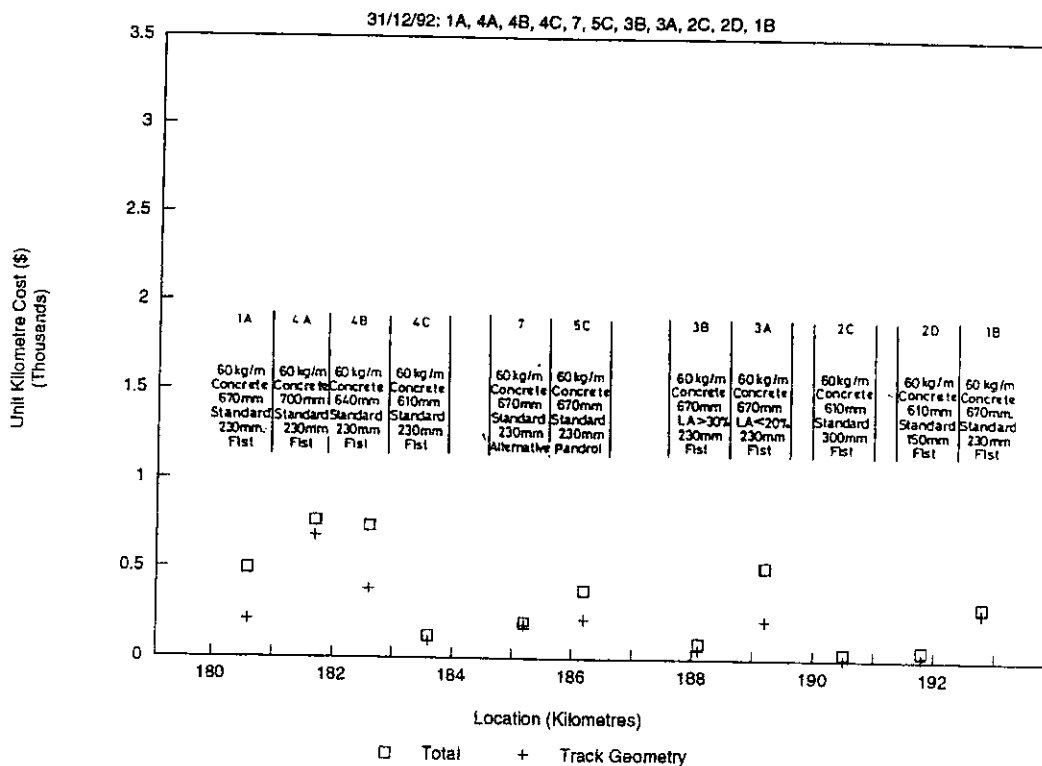
Figures 2.1.2(i)&(ii)
Maintenance Costs Up to 31 December 1992 (1992 Dollars)

Figures 2.1.2(i)&(ii) provide total and specific track geometry cumulative maintenance expenditure for the Test Sections up to December, 1992. It appears that more work has been done in the West Cunderdin sections, particularly Sections 5A and 5B, (Figure 2.1.2(i): 163 to 173 Km) compared to the East Cunderdin sections (Figure 2.1.2(ii): 180 to 193 Km). Costs associated with travelling or waiting time are not included.

From Figures 2.1.2(i)&(ii), track geometry maintenance expenditure for the control Test Sections 1A and 1C were approximately 50% of the total expenditure reported. For most of the other sections, the proportion was above this.

In contrast with the concrete sleeper sections, track maintenance expenditure for the timber sleeper section, Test Section 5B with 60Kg rail, were excessive. As noted in Section 2.4.6, this was reflected in the greater level of structural deterioration of karri sleepers and track structure visually observed during physical inspections. Similar expenditure was not evident for the only other timber sleeper section, Test Section 6B with 68 Kg rail.

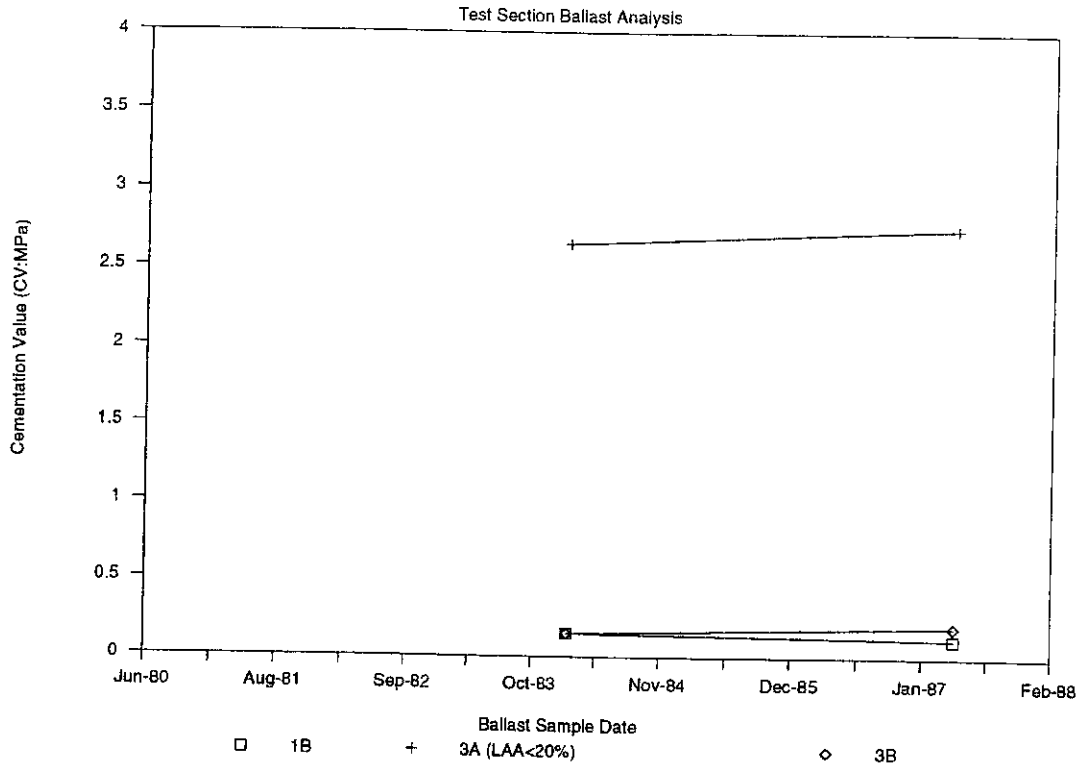
Figure 2.2.4(i): Cementation (CV Index)

The noted differences in abrasive characteristics between the two ballast types was also contrasted with cementation value results. In this case, the severe abrasive characteristics for 3A ballast were accompanied by higher strength cementation (above 2MPa). The Meckering ballast (Test Section 3B) appeared to offer a compromise with both reasonable abrasive character and reduced cementation strength. It has been argued (Selig and Waters, 1992) that cementation test methods do not simulate field conditions and cementation values, may not measure the actual tendency for cementation to be a problem in-situ.

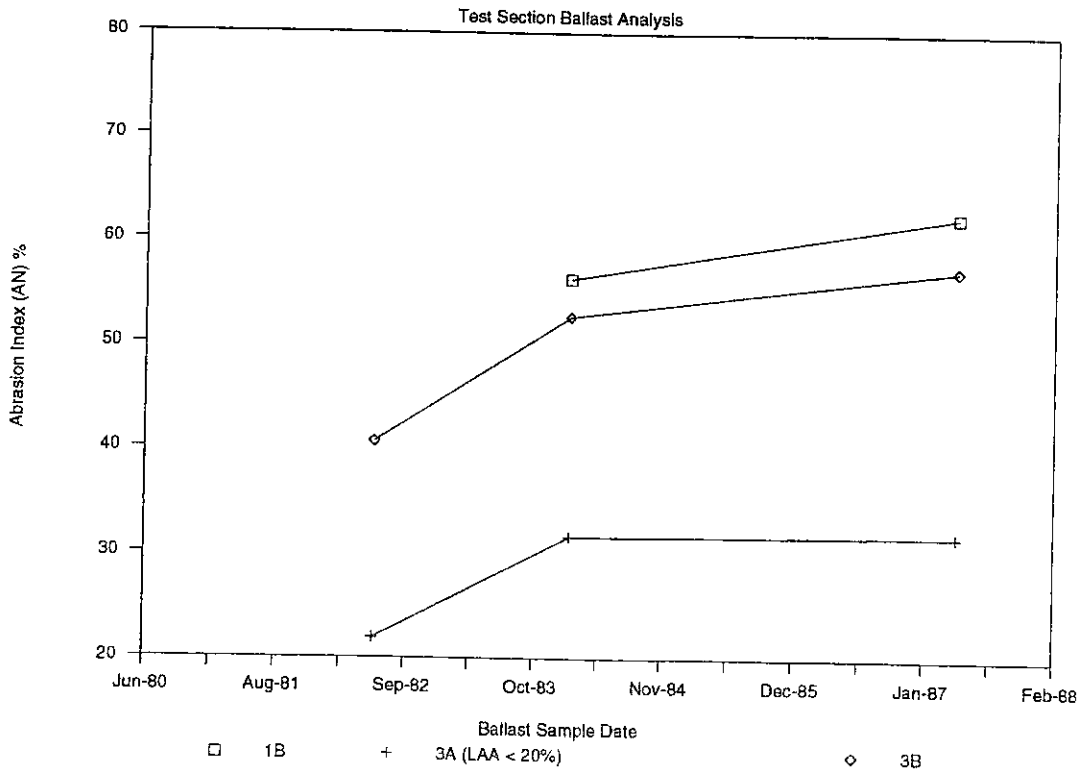
Figure 2.2.4(ii): Abrasion (AN Index)

The ballast in Test Section 3A was made from tougher material (sourced from Hampton Quarry at Kalgoorlie with LAA < 20%) than Meckering quarry material. This difference was consistent with the LAA test results in Appendix 9. With the combined Abrasion Number (AN) introduced in Section 2.2.3.4, the apparent abrasion was about 30% for Test Section 3A to nearly 60% for 3B. However, the corresponding hardness (MA index) results indicated little difference in particle hardness.

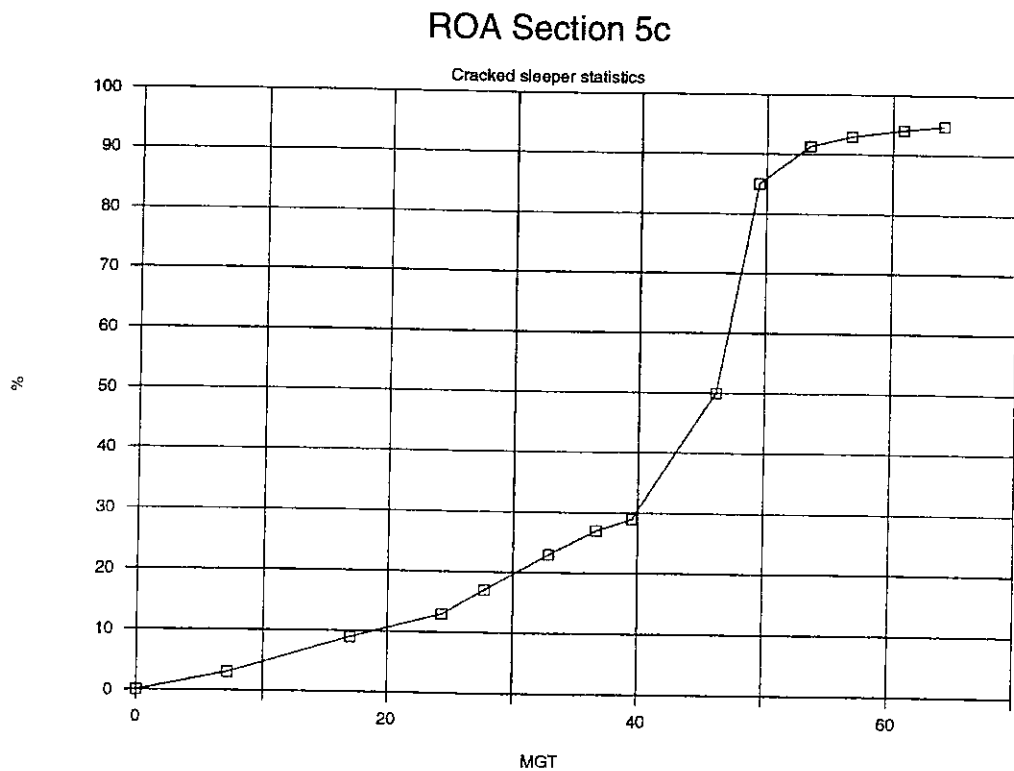
Figure 2.4.7.5
Test Section 5C: CR-2 Sleeper Cracking v Load Statistics

A summary report was prepared detailing performance up to April 1987 of the Section 5C CR-2 sleeper (Inspection #1 through to Inspection #11), see WESTRAIL report TS 403.1/17, Page 1987. During this period the following cracking performance statistics had been recorded.

Following a request from Australian National, 10 CR-2 sleepers were removed from Section 5C and dispatched to AN for analysis. The new CR-3 type sleepers was installed as the replacement. In subsequent inspections, no cracking of the new CR-3 sleepers was observed.

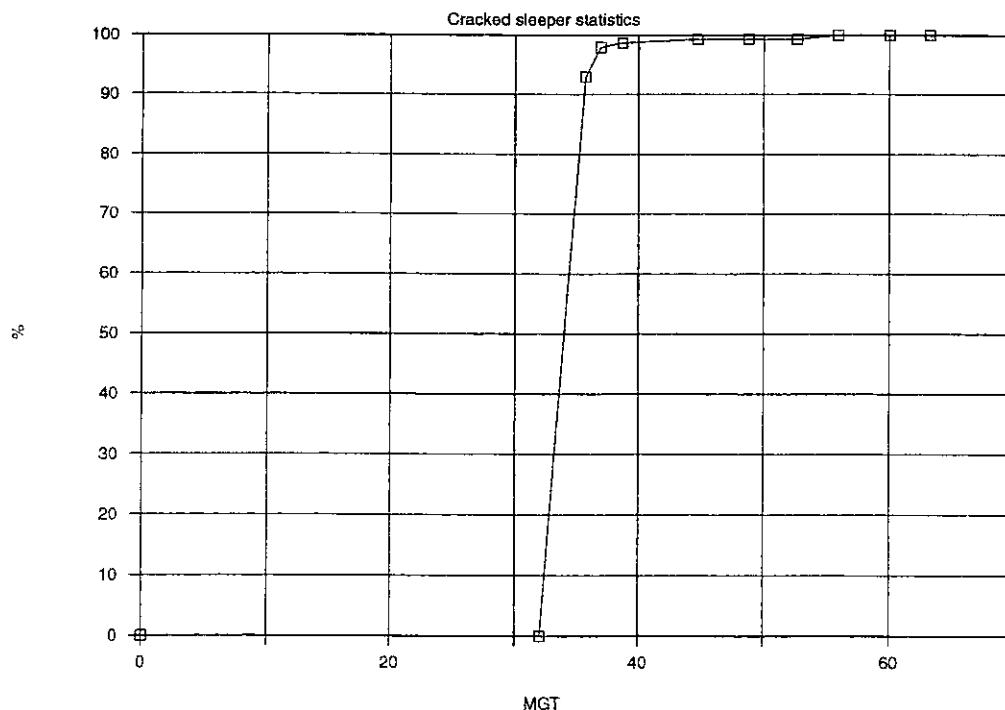
Figure 2.4.8.2
Test Section 7: Tunnelcrete Sleeper Cracking v Load Statistics

A summary report was prepared detailing performance up to April 1986 of the Vossloh fastening system (Inspection #1 through to Inspection #9), see WESTRAIL report TS 403.1/15, Page 1986. All of the Tunnelcrete sleepers had developed cracks which were still propagating. Most appeared to generate from the fastening bolt hole laterally (perpendicular to the rail) into the gauge and field portions of each sleeper. During this period the following cracking performance statistics had been recorded.

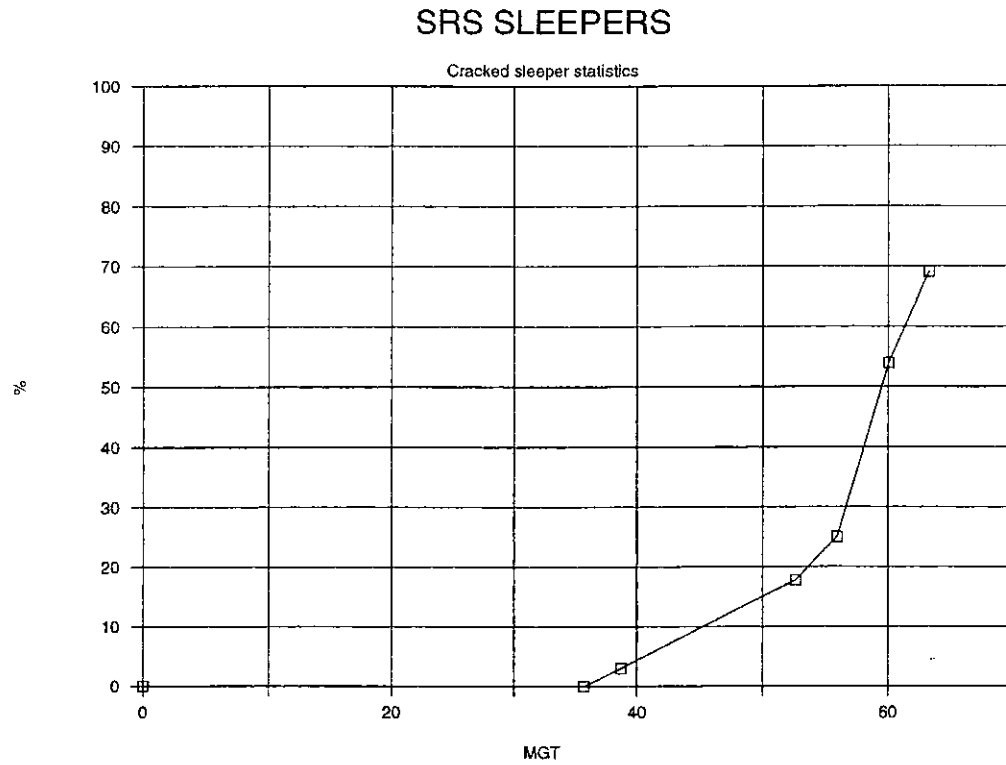
Figure 2.4.8.4
Test Section 7: SRS Sleeper Cracking v Load Statistics

A summary report was prepared detailing performance up to October 1987 of the Hambo fastening system (Inspection #1 through to Inspection #12), see WESTRAIL report TS 403.1/21, Makin 1988. During this period a significant portion of the Swedish Rail System (SRS) sleeper has developed cracks. Clip and insulator skewing, damaging and dislodging were also common occurrences. During this period the cracking performance statistics of Figure 2.4.8.4 had been recorded.

All SRS sleepers (Hambo fastening) were reported to have become crack.
